2016

UPPER GALLATIN RIVER WATERSHED

WATER QUALITY REPORT

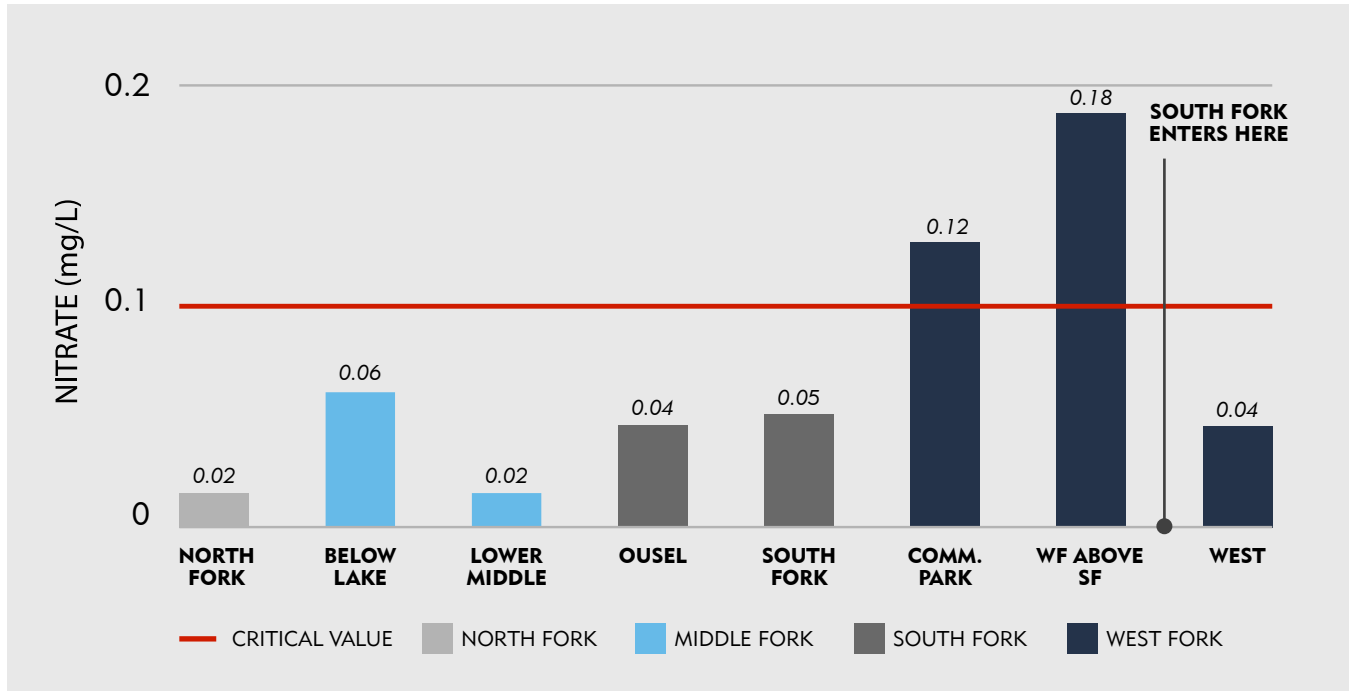
FIGURE 2A. WEST FORK WATERSHED AVERAGE SUMMER NITRATE | 2000-2016

Figures 2A & 2B. Average summer nitrate concentration in the West Fork Watershed (2A) and the mainstem Upper Gallatin River (2B) from 2000 to 2016. Field sites correspond with the sites shown on Figures 1A and 1B; TF is not included because it is on the Taylor Fork. If nitrate exceeds the 0.1 mg/L “critical value” during the growing season (July 15th to September 30th), elevated nitrate may cause excess growth of algae which depletes dissolved oxygen vital to aquatic life. Average nitrate measured at “Community Park” and “WF above SF” exceeded the critical value for nitrate between 2000 and 2016.

Two of the monitoring sites located in the Meadow Village downstream of the Little Coyote bridge (“Community Park” and “WF above SF”) demonstrated average nitrate concentrations that exceeded recommended levels between 2000 and 2016 (Figures 2A & 2B). Nitrate is a form of nitrogen readily available to plants and animals. Elevated nitrate stimulates growth of algae which depletes dissolved oxygen vital to aquatic life. In addition, excess algae on the streambed can reduce the biodiversity of stream insect populations. Potential human sources of nitrate to the West Fork include fertilizer, land application of treated wastewater effluent on the Big Sky Golf Course and Big Sky Community Park, effluent from privately owned septic systems, and storm water runoff.

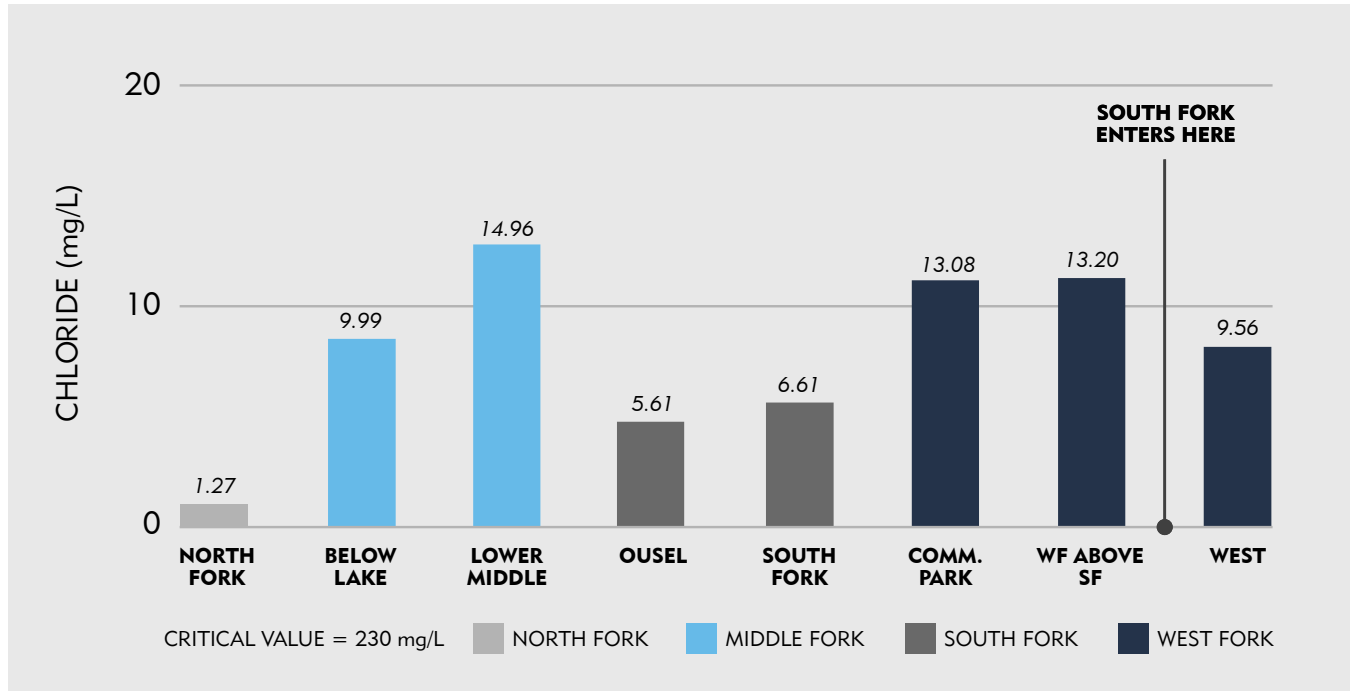
FIGURE 3A. WEST FORK WATERSHED AVERAGE CHLORIDE | 2012-2016

Figures 3A & 3B. Average chloride concentration in the West Fork Watershed (3A) and the mainstem Upper Gallatin River (3B) from 2012 to 2016. Field sites correspond with the sites shown on Figures 1A and 1B; TF is not included because it is on the Taylor Fork. Chloride can be toxic to aquatic life when the concentration exceeds 230 mg/L. All measurements were well below the critical value; however, average chloride concentrations in the West Fork and the Middle Fork were elevated above baseline conditions.

Chloride concentrations measured in the West Fork and the Middle Fork were elevated above background conditions (Figures 3A & 3B), but were well below the concentration that is toxic to aquatic life. Chloride is a water-soluble salt that can be toxic to aquatic life at very high concentrations. Wastewater and road salt likely contribute to elevated chloride levels in these streams.

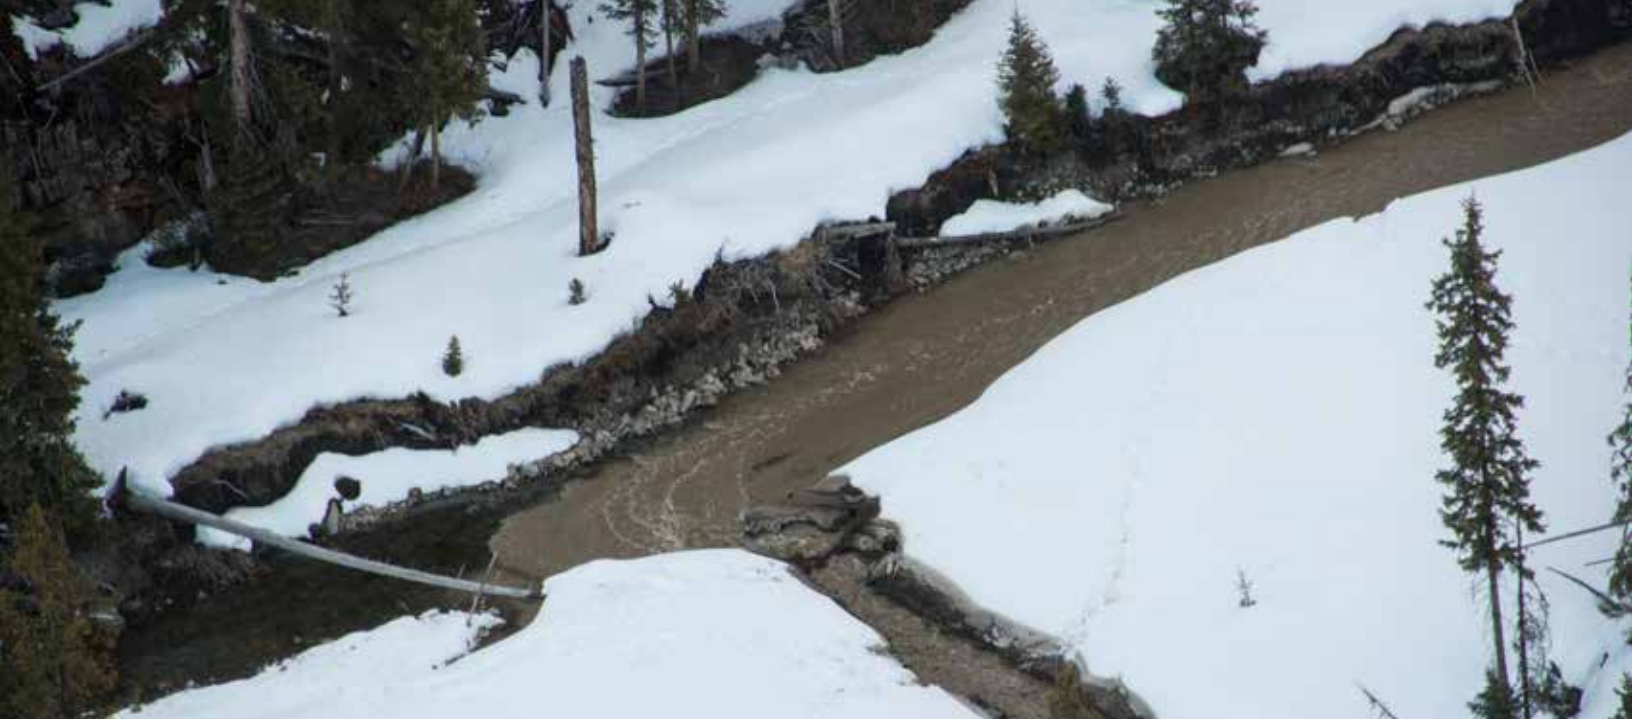
The confluence of the South Fork and Second Yellow Mule Creek in early March 2016. The highly turbid waters of Second Yellow Mule Creek carried sediment from the hillside below the Yellowstone Club wastewater effluent storage pond to the South Fork. The South Fork is noticeably clearer upstream of the confluence with Second Yellow Mule Creek.

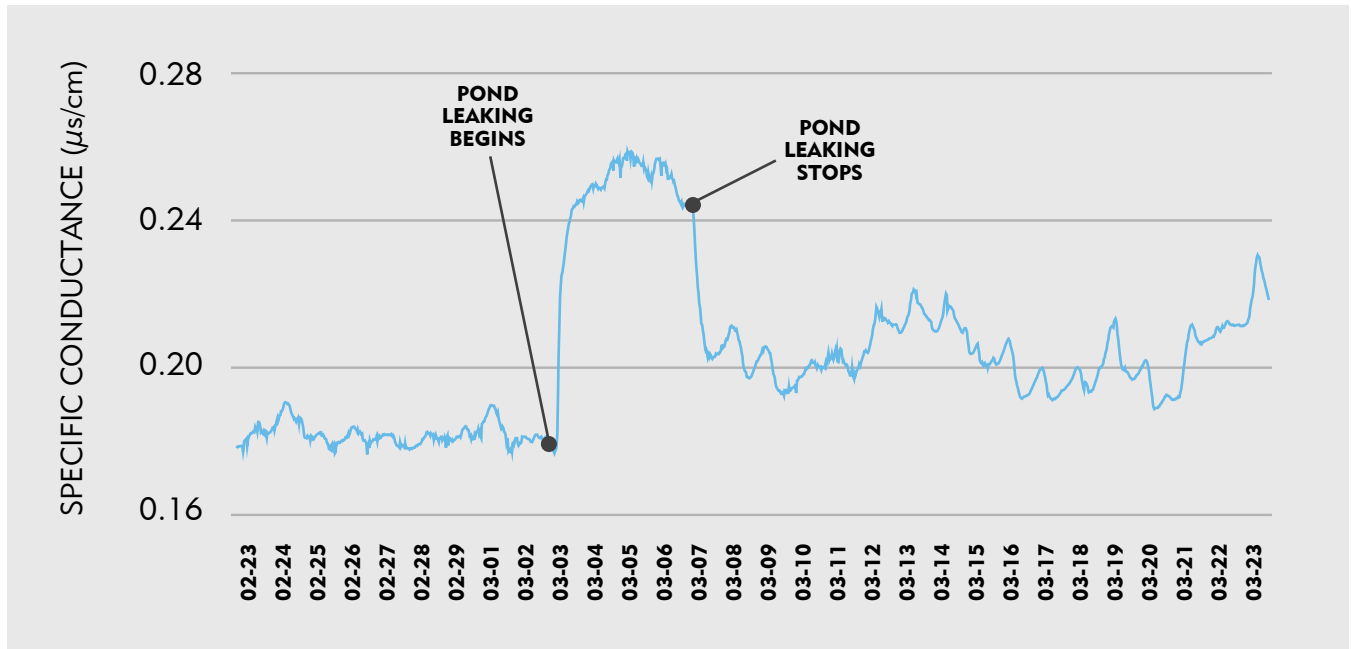
FIGURE 11. SOUTH FORK SPECIFIC CONDUCTANCE | FEB. & MAR. 2016

Figure 11. Specific conductance (charged particles) measured every 30 minutes at the South Fork continuous monitoring station from February 23rd to March 23rd, 2016 (Figure 1B). The data shows a rapid increase in charged particles on March 3rd at 6:30 AM when the wastewater effluent pond at the Yellowstone Club started leaking and a sharp decline on March 7th at 7:30 PM after the pond had finished draining.

Sediment carried by the spill water increased the specific conductance (amount of charged particles) in the South Fork. The South Fork continuous monitoring station measures specific conductance every 30 minutes (Figure 1B). The rapid increase in specific conductance on March 3rd and precipitous decline on March 7th mark the period when the pond was actively leaking (Figure 11).
